# Manhole Inspection Summary

Manhole # S29II1010MH

**Location** Address: **OVERHILL RD**

Cross Street: **WICKFORD RD**

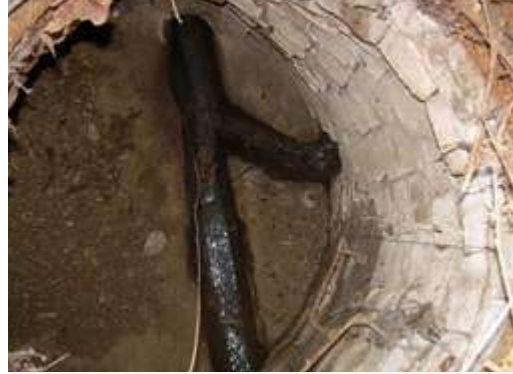
Top View

**Bench** ☒ Exists Material: **Concrete** ☐ Parged ☒ **Debris** (not Condition related)

**Steps** Count: **2** Missing: **0** ☒ **Corroded**

Corroded steps. Bench debris.

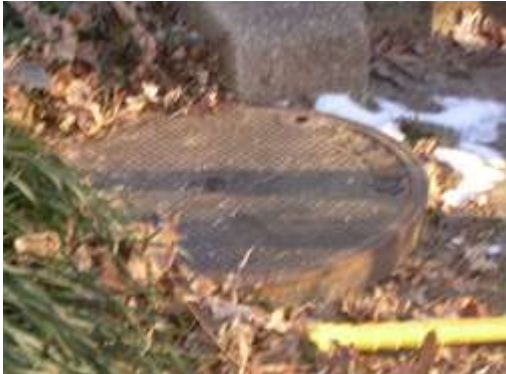
Comments **The MH was found with its lid open.**

Lid out of frame

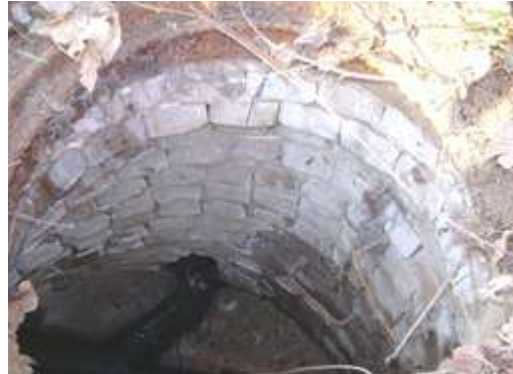
Defect

**Frame** Offset: **0** (in.) Condition: ☐ Sound ☐ Cracked ☒ **Leaks**

Condition: ☐ Sound ☐ Cracked ☐ Root Intrusion ☐ Loose Brick ☒ **Deteriorated**

Infiltration: ☐ None ☐ Joint ☐ Cracks ☒ **Mortar** ☐ Roots ☐ Wall

Infiltration: ☐ None ☐ Joint ☐ Cracks ☒ **Mortar** ☐ Roots ☒ **Wall**

Frame leak. Adjustment, Corbel and Barrel deterioration and infiltration.

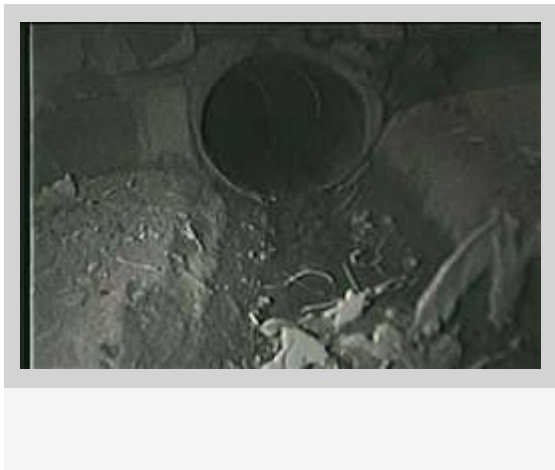
6 in. Circular Gravity Sewer  
Pipe In @ 6 O'Clock

Infiltration: **Evidence** Pipe Seal Cond: **Cracked**
